BUSH FIRE ASSESSMENT REPORT

For the Proposed Residential Development
at

**45 BLUEFISH CRESCENT,
TASCOTT, NSW
(LOT 64 IN DP 237498)**

May 2020

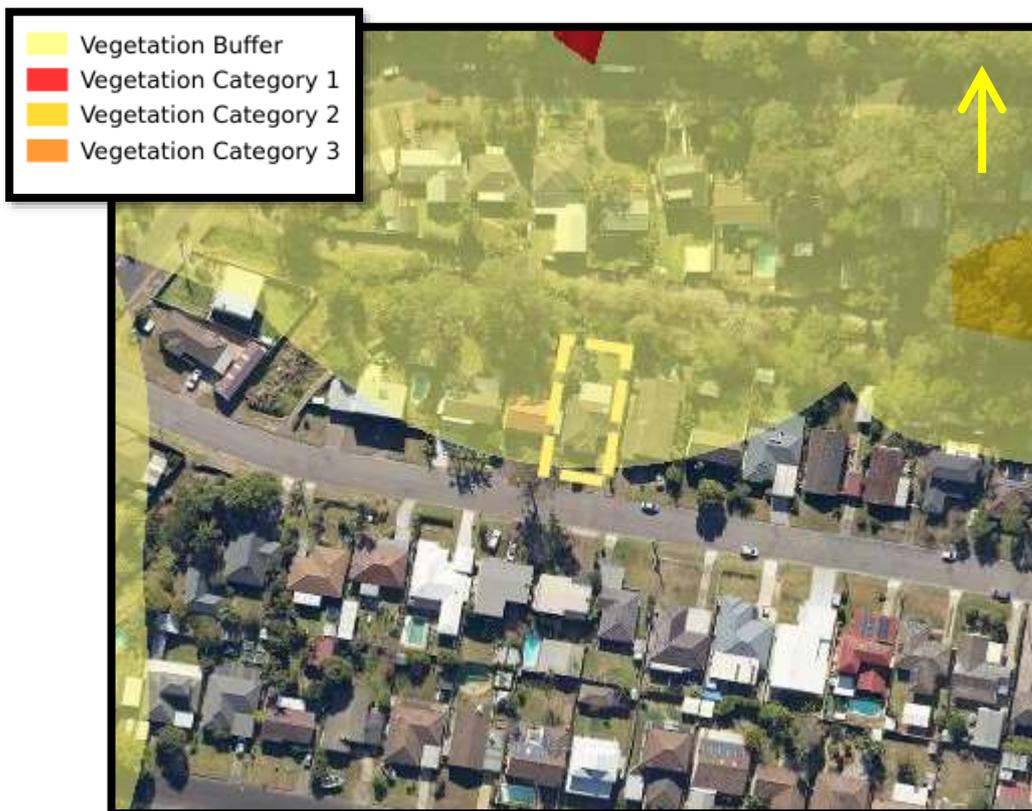
Figure 1: Bushfire Mapping (site boundary in yellow)
Source: Department of Planning, 2020

The subject site has been mapped as bushfire prone land (See Figure 1); therefore, the purpose of this BFAR is to provide information to Central Coast Council to ascertain compliance or otherwise with AS3959-2018 'Construction of Buildings in Bush Fire Prone Areas' and PBP.

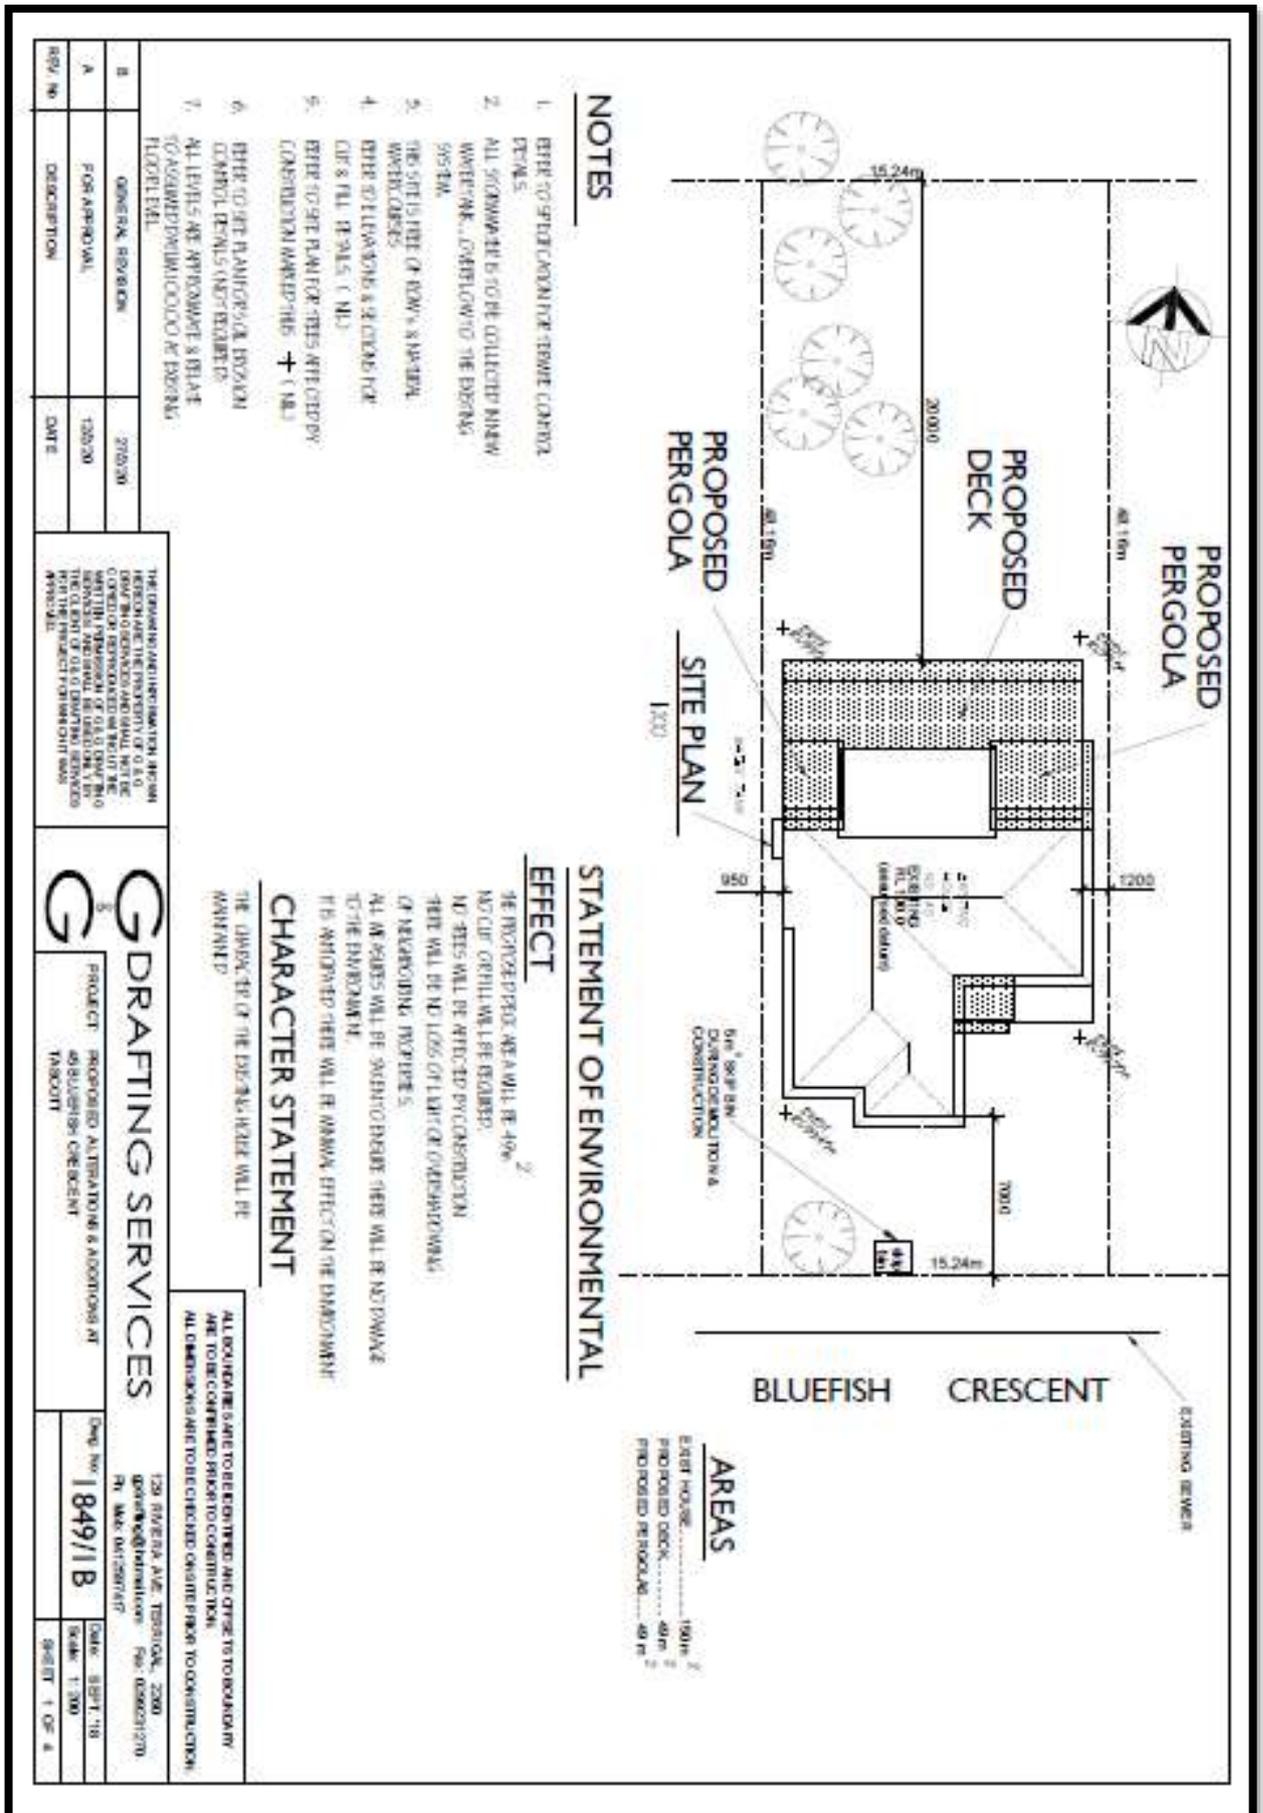
Figure 2: Proposed Development Site Plan

The site contains an existing dwelling and the proposed development will involve the construction of additions and alterations to the dwelling. Figure 2 provides a site plan of the proposal.

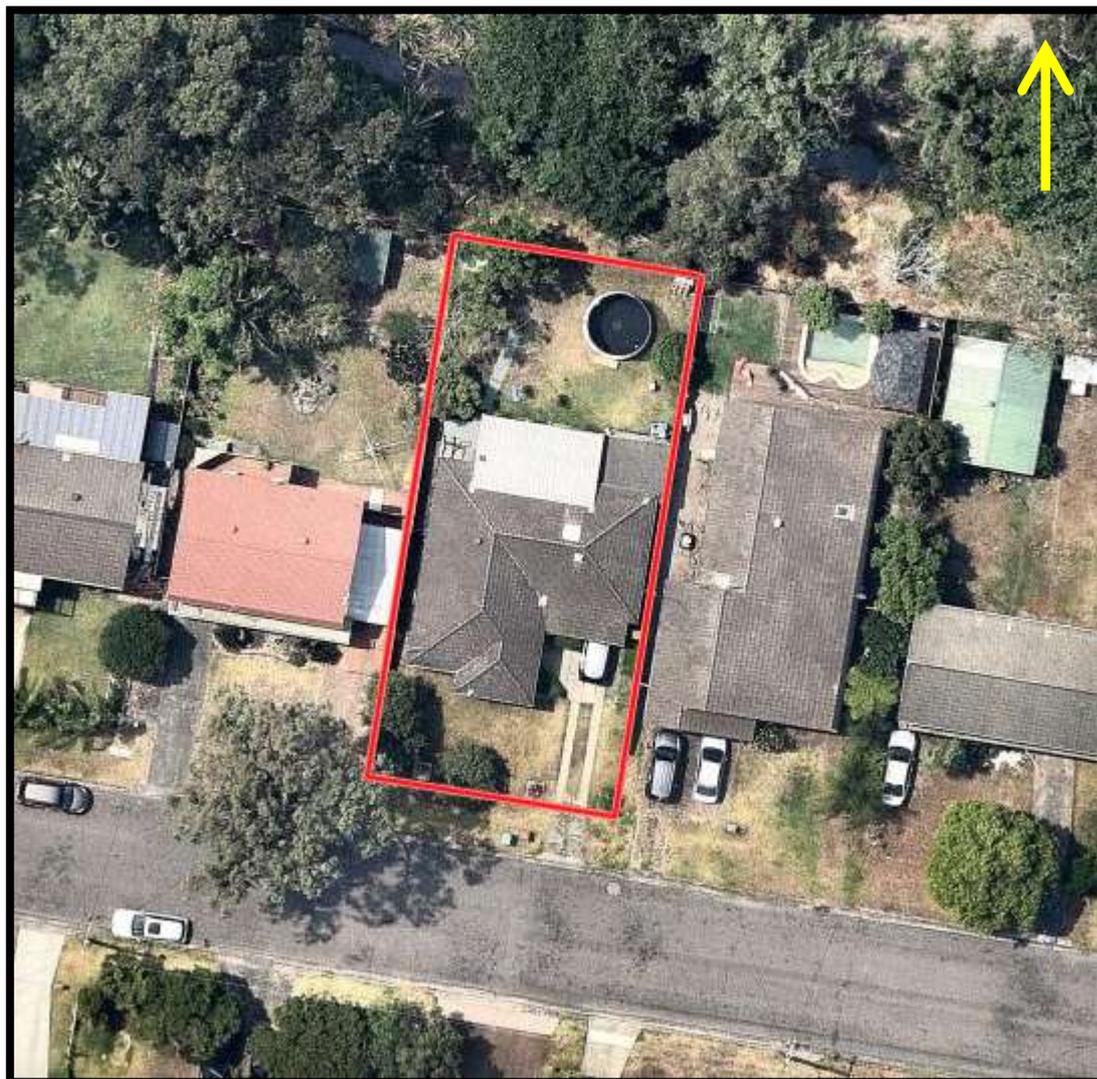
Figure 3: Aerial Photograph of the site (site boundary bordered in red)
Source: Nearmap, 2020

The site is a residential parcel of land that contains an existing dwelling on the middle portions of the site. Land conditions within the site consist of managed lawns and landscaped gardens.

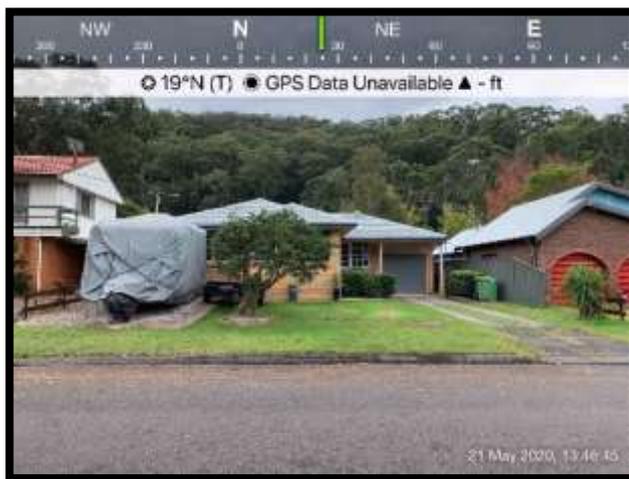
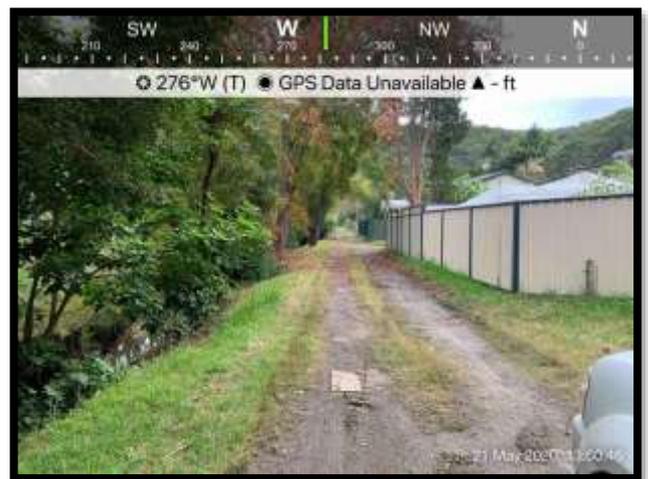
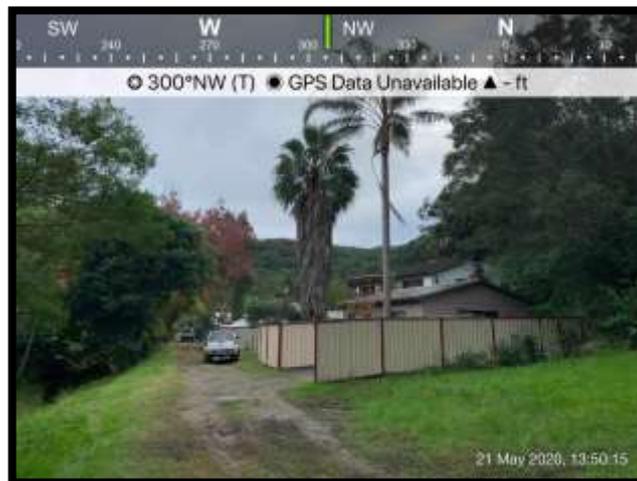
Note: See figure 5 for photograph location and direction.

To the north beyond the site, a drainage reserve and access road, rows of developed residential allotments and The Broadwaters is vegetation that has been mapped as containing *Sheltered Blue Gum Forest*. This vegetation meets with the Keith (2004) description of a 'wet sclerophyll forest'. In accordance with Appendix 1 in PBP, this vegetation will be assessed as **Forest** as per PBP.

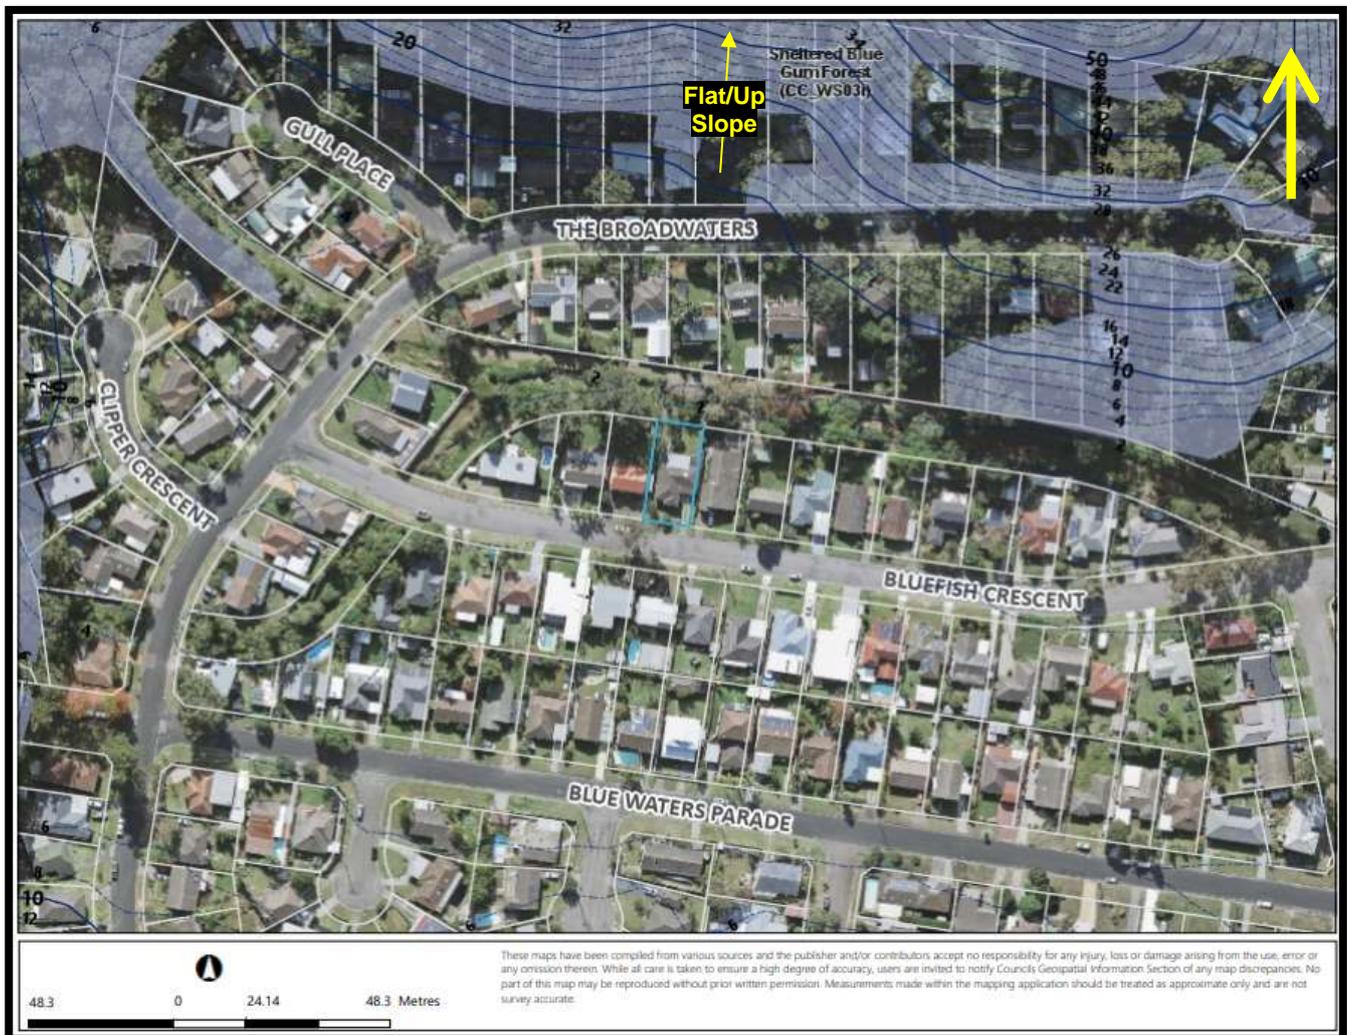
Figure 4: Topographic Mapping surrounding the proposed development
Source: Central Coast Council, 2020

In regards to the site, the effective slopes for each hazard facing were inspected and calculated through a combination of topographic mapping from the Central Coast Council (2m contours) and ground-truthing. The effective slope measured 100m from the proposed development for the hazard facing aspects are;

North: Flat/Up Slope

Figure 4 provides the topographic and vegetation mapping for the site and surrounding area.

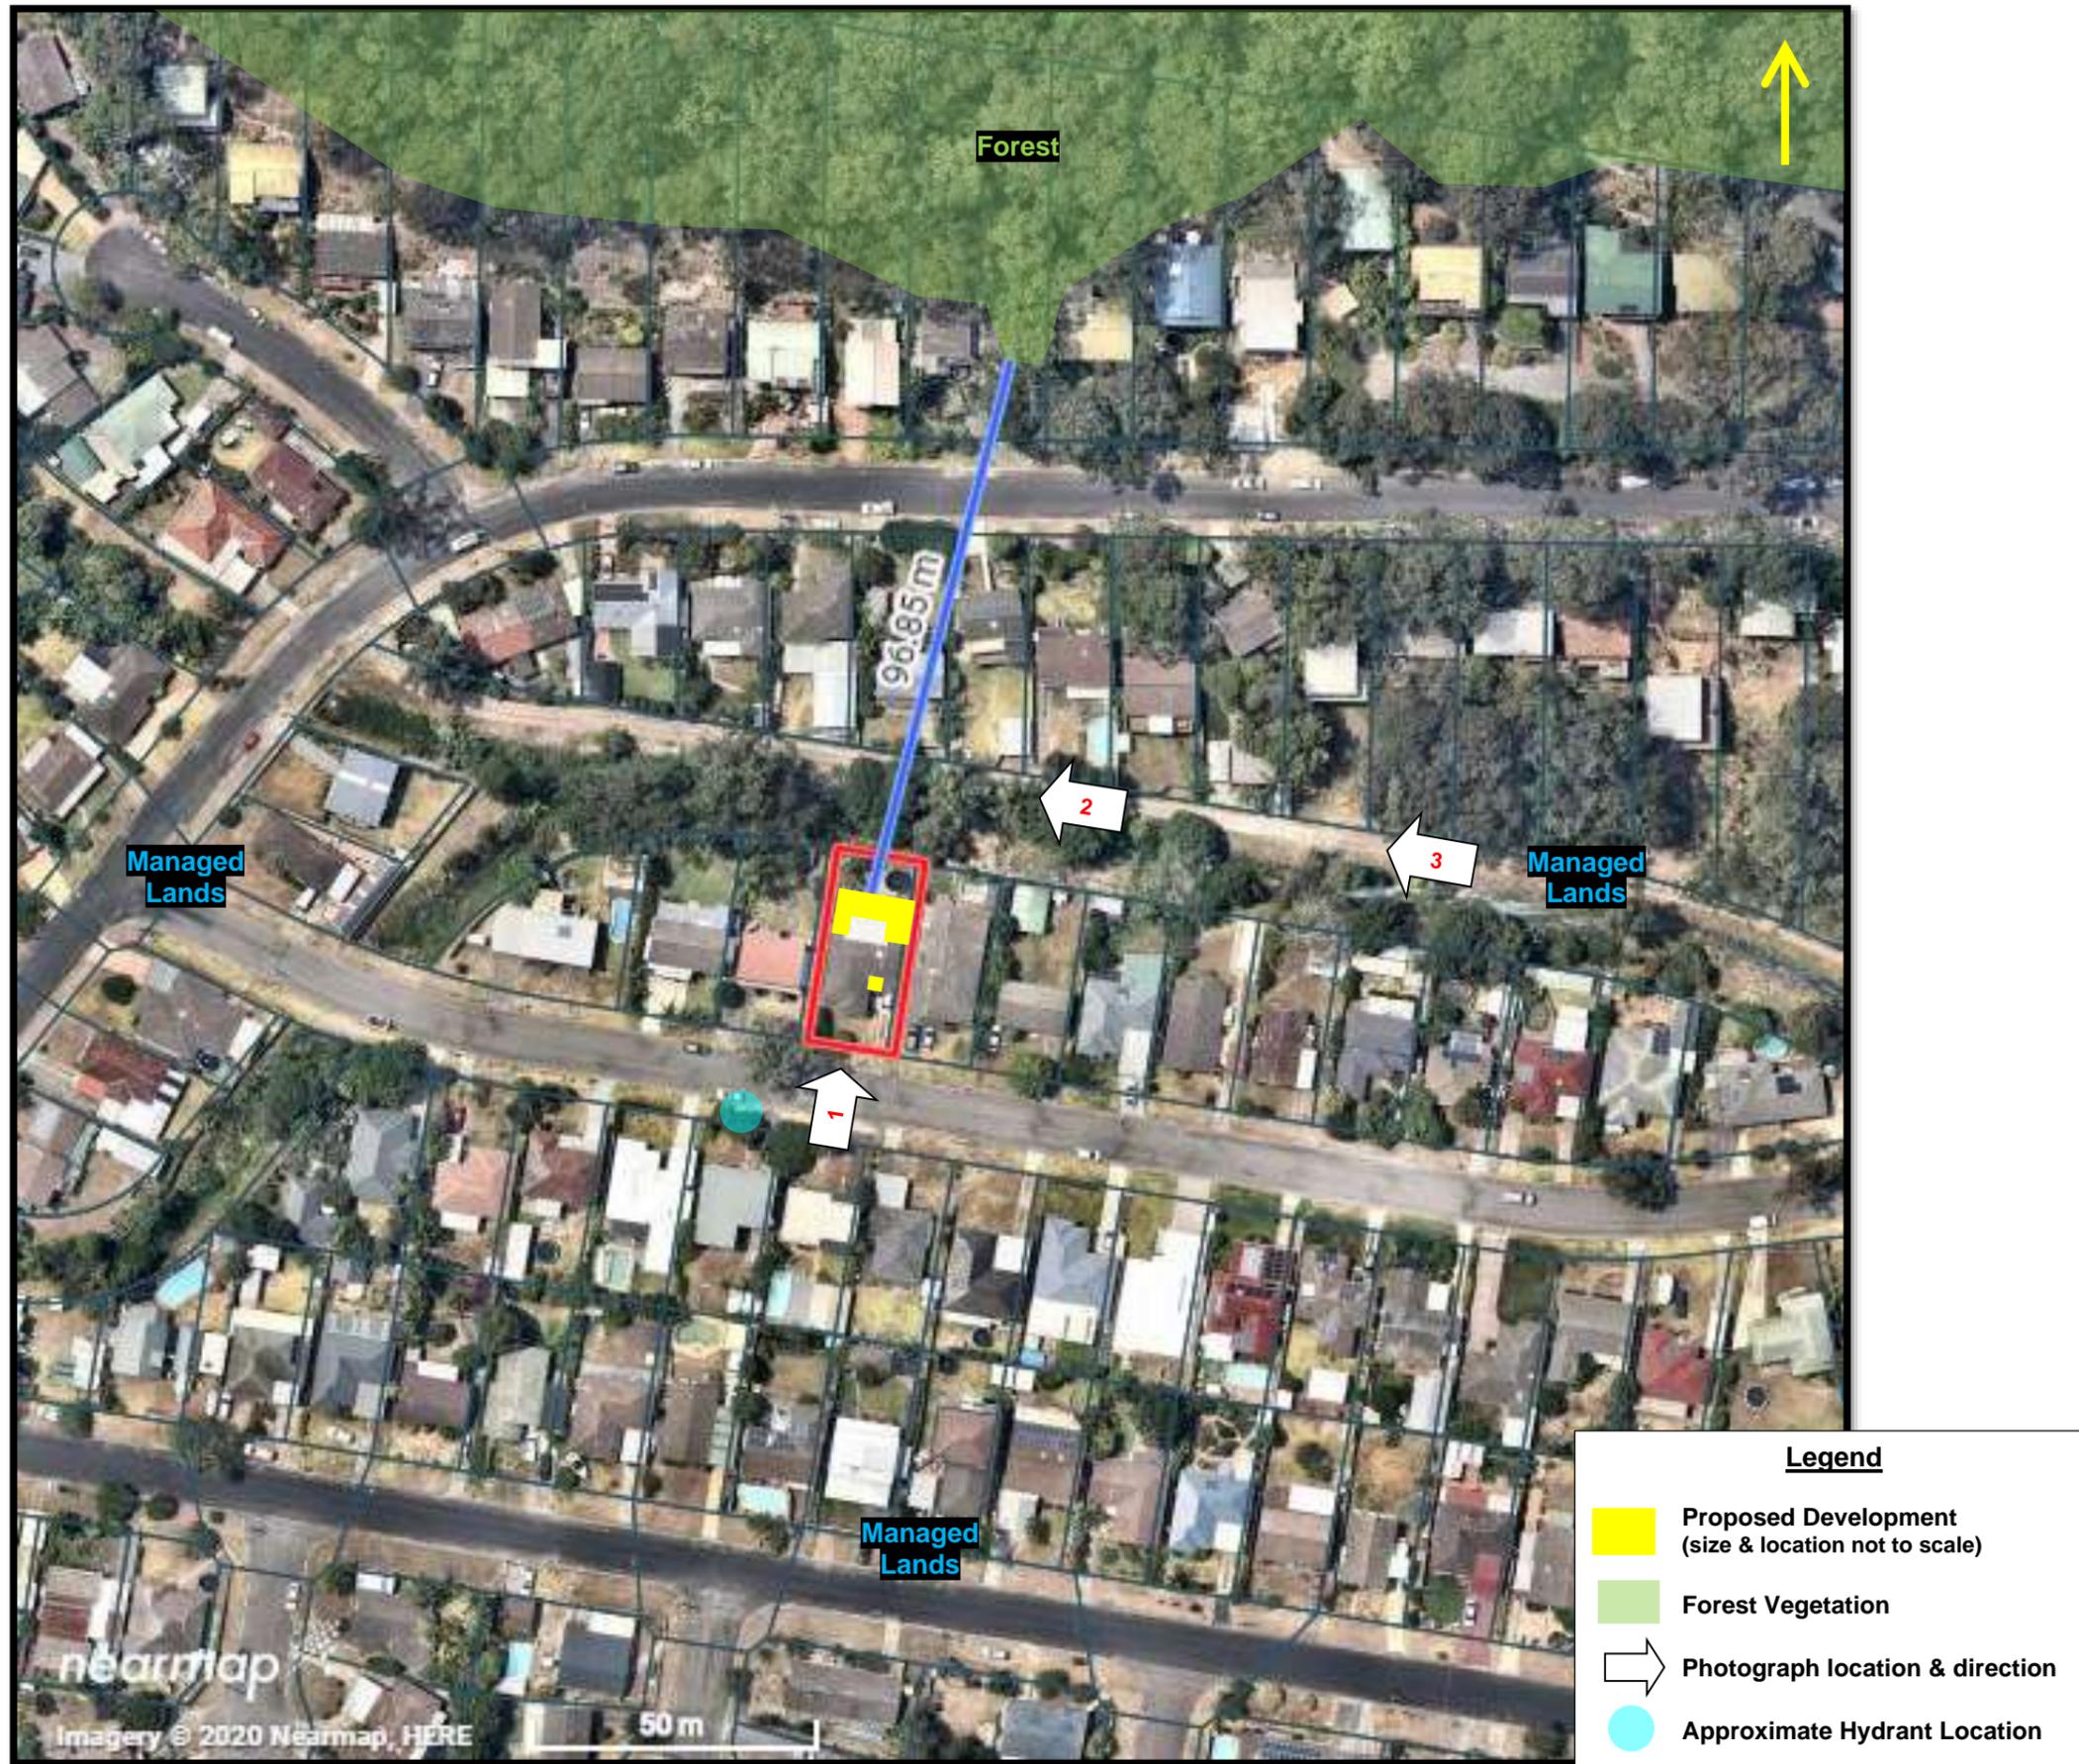
Figure 5: Bushfire Site Plan (site boundary bordered in red)
Source: Nearmap, 2020

With reference to Table 1 and Table A1.12.5 in PBP, the proposed additions will be subject to BAL 12.5 from the northern aspects as per AS3959-2018.

- **All areas currently maintained shall be maintained as an APZ for the lifetime of the development.**
- The APZ shall be maintained to meet with the requirements of an Inner Protection Area (IPA) as outlined in Appendix 4 in PBP.

- The **proposed development** shall be constructed to comply with AS3959-2018 **Sections 3 & 5 (BAL 12.5)** and section 7.5 in PBP.
